European Spine Society – The AcroMed Prize for Spinal Research 1997

Do “whiplash injuries” occur in low-speed rear impacts?

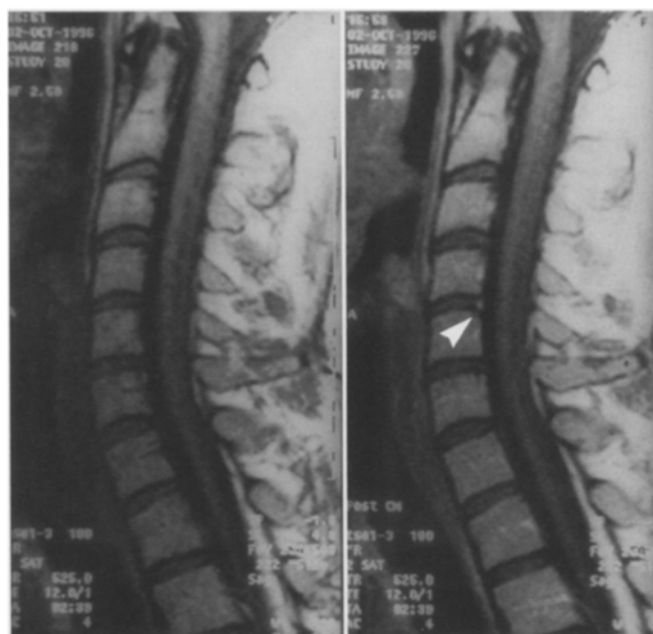
Fig. 1 Fast spin echo MR images of the cervical spine in the sagittal plane before the crash (FSE 525/12/180°). In this 30-year-old test subject, the right-hand image (enhanced with gadolinium) shows a circumscribed pattern of enhancement indicative of a degenerative tear in the posterior portion of the annulus fibrosus of vertebral segment C4–C5 (arrow)

The preliminary MRI studies revealed degenerative changes in seven test subjects (i.e., eight collisions). Protrusion of the intervertebral disks with slight compression of the epidural and subarachnoid space was seen in five test subjects. Protrusion completely compressing the epidural and subarachnoid space was seen in one test subject. This was the person involved in two tests. A degenerative annulus tear was found in another test subject (Fig. 1). Two test subjects experienced claustrophobic reactions that prevented completion of the MRI studies.

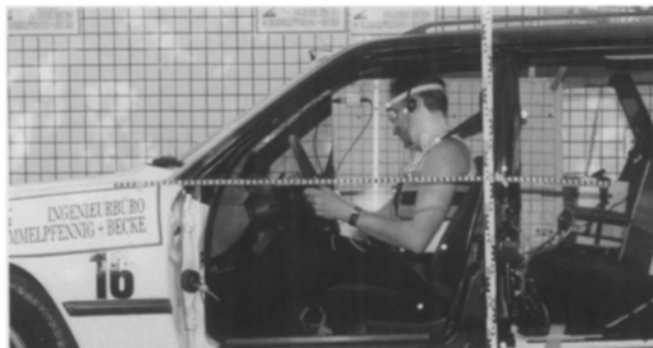
Fig. 2 Initial position of a male test subject immediately before a two-car collision. Note the blinds, the headset, and the leads connecting the test subject to biomechanical acceleration and electromyography (EMG) sensors

Anticipation by the test subjects was largely neutralized. Their vision was obscured by opaque eyeglasses and loud rock music was played on a Walkman (Fig. 2). In two test subjects, anticipation could not be excluded because the music was interrupted and the approaching vehicle could be heard. Activity of the neck muscles (sternocleidomastoideus, trapezius, and splenius capitis) was continuously recorded via surface electromyography (EMG). In two test subjects a complete EMG recording could not be achieved due to technical problems.

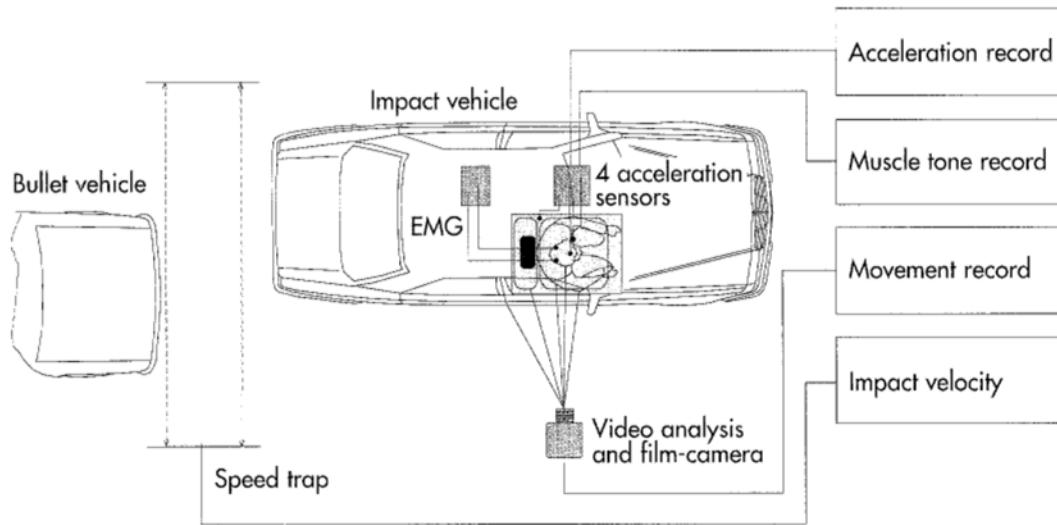
Fig. 3 Design of the experiment

nig und Becke) was used to record the longitudinal and vertical acceleration of the passenger compartments and the acceleration of the test subject's chest and head. Figure 3 provides an overview of the design of the complete experiment. All acceleration data were acquired simultaneously with the EMG data.

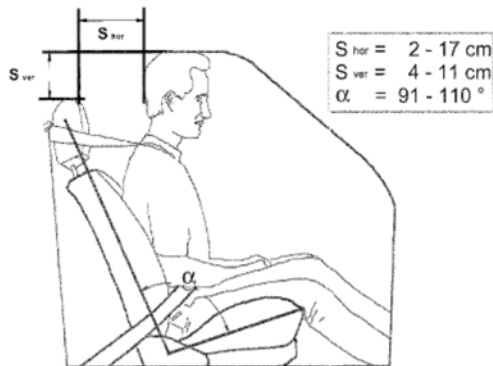
Fig. 4 Initial position in the car seat

The sitting position of all test subjects in the vehicle and the seat adjustments were photographed a few minutes before the test with a tripod camera under defined conditions (distance, height, and angle). The precise position of the movement markers, the horizontal distance between the head and headrest, and the vertical distance between the top of the head and the top of the headrest were measured and recorded. The horizontal distance s_{hor} ranged from 2 to 17 cm and the vertical distance s_{ver} ranged between 4 and 11 cm. The angle of inclination between the surface of the seat and the backrest varied between 91° and 110° (Fig. 4).

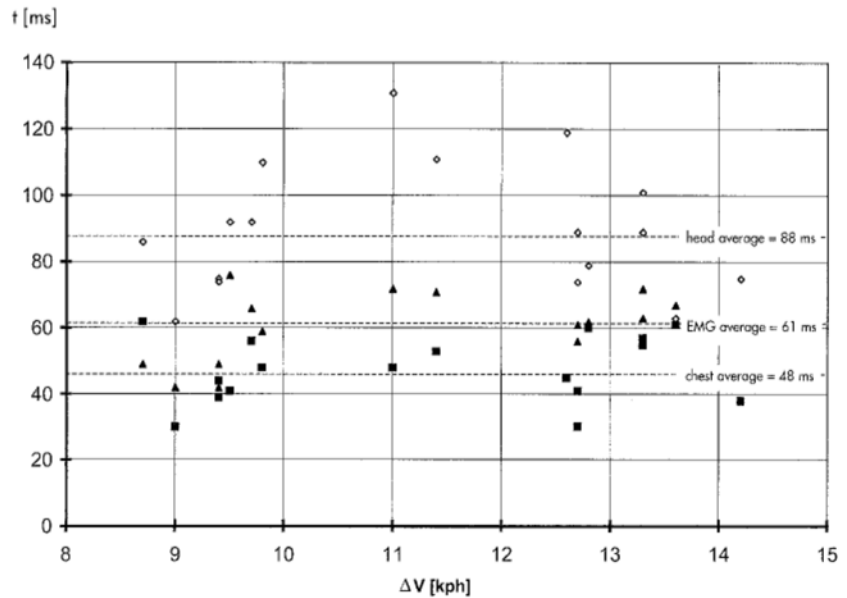
Fig. 5 Time delay between the beginning of acceleration of the passengers compartment and the biomechanical signals from the chest (■) and head (◇) together with the onset of the EMG signal (▲) over the velocity change due to collision

The time delay between the beginning of acceleration of the passenger compartment and the biomechanical signals from the chest and head together with the onset of the EMG signal, as a function of the velocity change due to collision for all two-car impacts is shown in Fig. 5. In this graph, the zero point is defined as the beginning of acceleration of the passenger compartment. Movement of the upper body (chest) begins on average approximately 48 ms after the beginning of acceleration of the passenger compartment, whereas a significant movement of the head is only detected about 90 ms after initial contact between the two vehicles. The detected neuromuscular reaction of the muscles of the back of the neck begins on average about 60 ms after the passenger compartment begins to accelerate and approximately 20 ms after the chest movement begins.

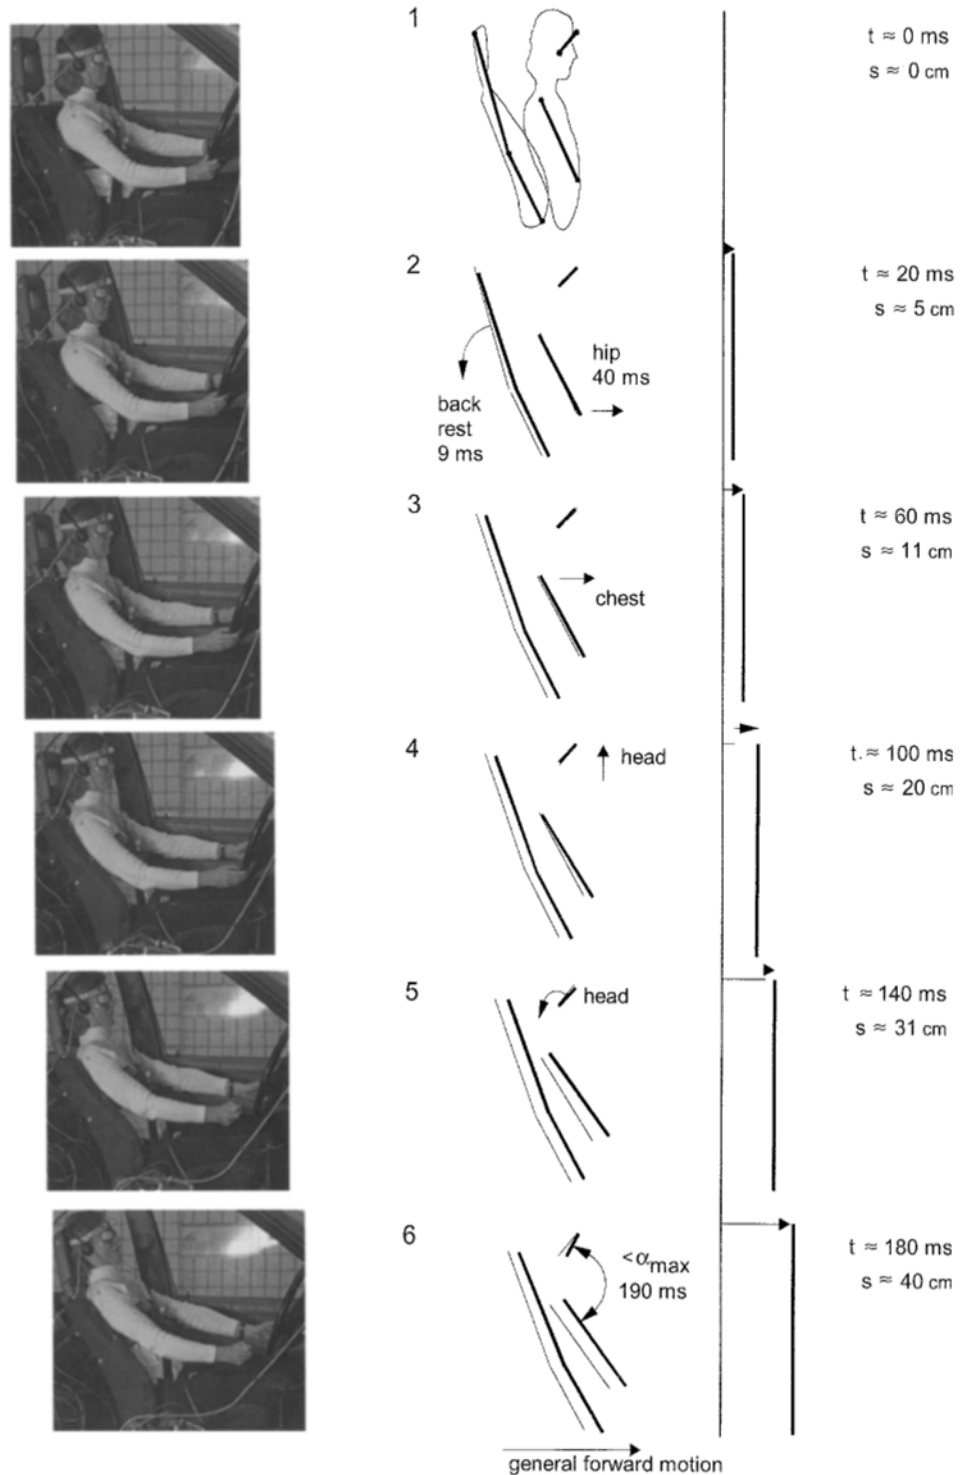
Fig. 6 Analysis of a primary motion with six constantly recurring motion phases. The images from the video camera are shown on the *left*. The movement markers are visible as bright spots on the seat and test person (forehead, center of gravity of the head, shoulder, and hip). As shown in the *top middle image*, these points were corrected together to allow separate tracking of the absolute motion of the seat, upper body, and head. In each of the consecutively numbered line diagrams, the current positions are shown with *solid lines* and the respective previous positions (approximately 40 ms previously) are shown with *dotted lines*. The times *t* and absolute distances *s* of the passenger compartment, relative to the time of initial contact of the vehicles and the rest position of the target vehicle respectively, are specified in the *right section* of the Figure. A description of the various phases is given in the text

Using the preliminary data of the biomechanical acceleration signals measured at the head and chest and the ten movement markers, we were able to divide passenger motion in a rear-end collision into one primary motion involving six constantly recurring phases (Fig. 6) and one secondary motion.

Phase 1: The passenger compartment and seat move toward the passenger’s resting body. By definition, the beginning of this phase is identical to the beginning of the collision, i.e., the time of the initial contact between the two cars. During this phase, the lower seat upholstery of the backrest is deformed in the region corresponding to the passenger’s pelvis.

Phase 2: This phase begins with the forward motion of the test subject’s pelvis. The friction between the surface of the seat and the volunteer’s thighs, and the frictional connection between the lumbar spine and the backrest, cause the passenger’s lower body to move forward. This reduces the angles between the torso and the head, although the head and upper body are not yet in forward motion. This produces flexion in the cervical spine.

Phase 3: Onset of upper body motion (chest). Because the force transmitted by the frictional connection between the backrest and the passenger continues upward to the thoracic spine from below through the hip, pelvis, and lumbar spine, the chest begins to participate in the forward motion. The head remains at rest. This introduces a relative translational motion between the upper body and the head. Remarkably, at the onset of this shear stress, the passenger compartment and seat have already moved forward approximately 11 cm.

Phase 4: The force travelling upward through the frictional connection reaches the shoulder blades, forcing the passenger into extension. The passenger appears to rise up in the seat in what is known as “ramping”. By this time, the seat and passenger compartment have already moved

forward approximately 20 cm while the head still remains at rest.

Phase 5: This phase is characterized by the maximum angle of deformation of the backrest and the completion of passenger extension. The extension motion of the head has begun, i.e., the angle between the upper body and the head increases noticeably.

Phase 6: The maximum angle of extension is reached after the back of the head has come into contact with the headrest. The passenger is in full extension, and now every part of the body is involved in the forward motion of the seat and passenger compartment.

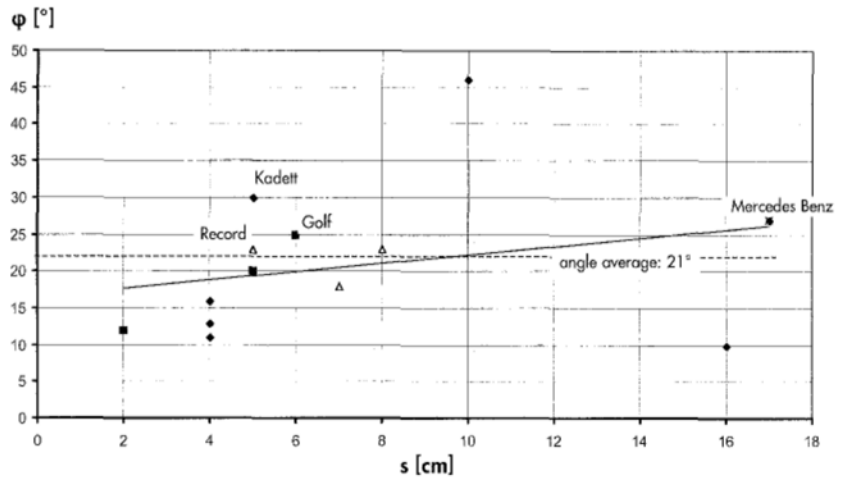
Fig.7 Relative angle in relation to the distance from the headrest

Motion analysis can determine the maximum angle and the maximum relative angular velocities (12 of 17 car collisions) between the upper body and the head in the extension motion. Figure 7 shows the resulting relative angle as a function of the horizontal distance between the back of the test subject’s head and the headrest. This varied between slightly less than 10° and 47°. The average extension angle was 20°. The maximum relative angular velocities (Fig. 8) ranged between 200° per second and a

Motion analyses of the test persons during the entire collision phase revealed the trend that the maximum resulting relative angle between the upper body and the head increases with the increase in the horizontal distance between the back of the head and the headrest. However, hyperextension of the cervical spine, which has been discussed in the literature [10, 19] as a possible cause of injury, definitely does not occur in vehicles equipped with headrests at a ΔV of up to 15 km/h. This finding concurs with the data of Szabo and Welcher [18], who also failed to observe hyperextension. A notable finding in our examination was the extent of the relative translational motion between the upper body and the head (phase 3 of the motion analysis). The significance of such a translation as a possible cause of injury is not yet clear. Penning [10]

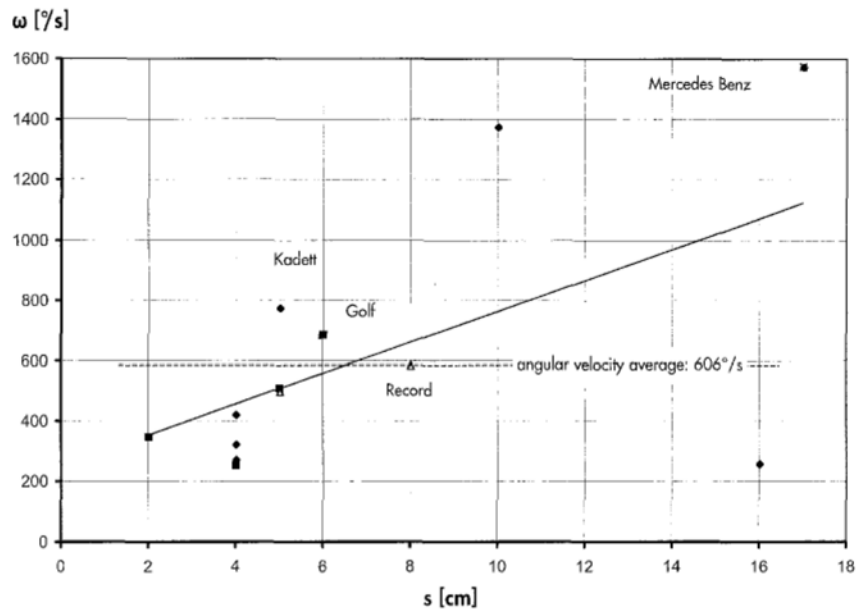
Fig.8 Relative angular velocity in relation to the distance from the headrest

maximum of slightly less than 1600° per second. The average angular velocity was 606° per second (12 of 17 car collisions).

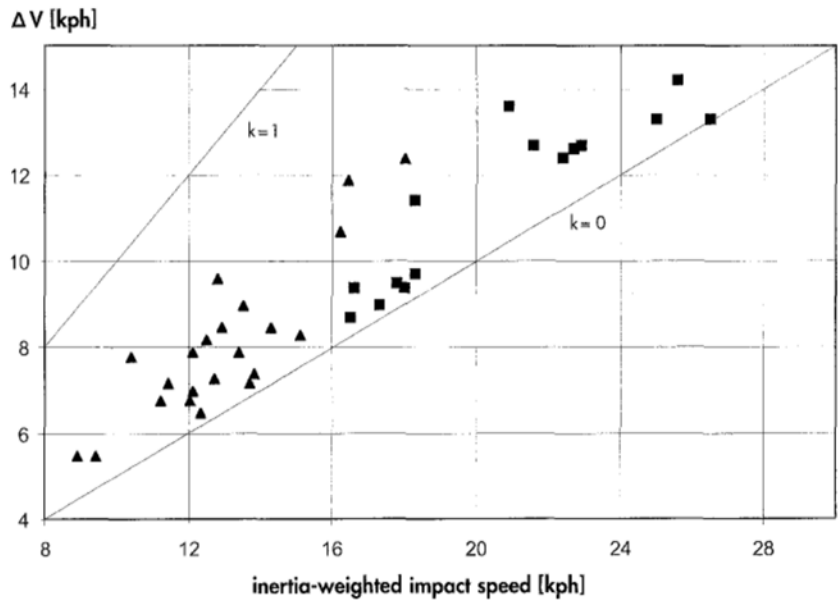
Fig.9 Change in speed due to the collision (ΔV) in relation to the inertia-weighted impact speed v_1 (boundary cases: $k = 0$: plastic collision; $k = 1$: elastic collision)
 ■ = Study 1997; ▲ = pre-study 1993

Figure 9 documents the inertia-weighted impact speed via the velocity change due to collision for all the crash tests. The inertia-weighted impact speed neutralizes the influence of differences in vehicle weight and is thus more suitable for comparing collision processes.

The inertia-weighted impact speed of the bullet car ranged from 16.4 km/h to 26.4 km/h (average 20.9 km/h). The change in velocity ranged from 8.7 km/h to 14.2 km/h (average 11.4 km/h). The mean acceleration of the target car ranged from 2.1 g to 3.6 g (average 2.7 g). The impact speed of the bullet bumper car ranged from 11.0 km/h to 13.5 km/h (average 12.2 km/h). The change in velocity ranged from 8.3 km/h to 10.6 km/h (average 9.9 km/h). The mean acceleration of the target bumper car ranged from 1.8 g to 2.6 g (average 2.2 g). The velocity change of the test vehicles due to collision could be precisely calculated by integrating the acceleration signals from the passenger compartments over time.

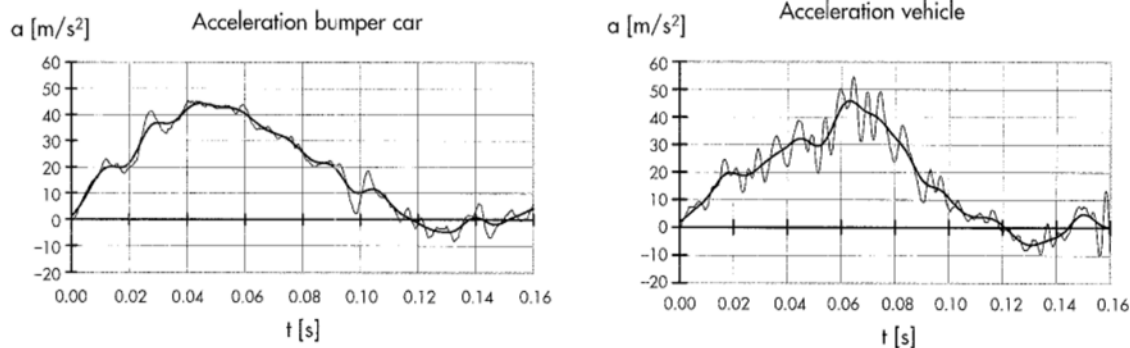
Fig. 10 Comparison of the acceleration signals from the bumper car (left) and automobile (right)

Comparison of the acceleration signals between automobile and bumper car collisions resulted in very similar curves (Fig. 10). Deviations were seen only in head acceleration as a result of unrestricted head motion in the bumper car.
